# CARRY PUMPS

## 6" MOTOR AND LEAD REPLACEMENT GUIDE

# 6" CROWN MODIFICATION

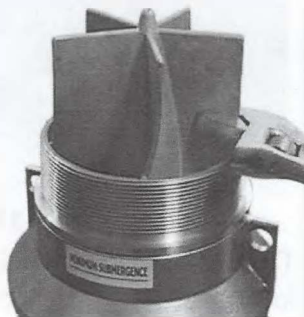
Figure 1

**1.** Remove the recuperator from the pump. (See Figure 1) **This is installed with left handed threads.** To remove turn clock-wise. This may require some strength. You may use a crescent wrench to hold one of the lugs of the recuperator and tap the opposite fin with a hammer to loosen.

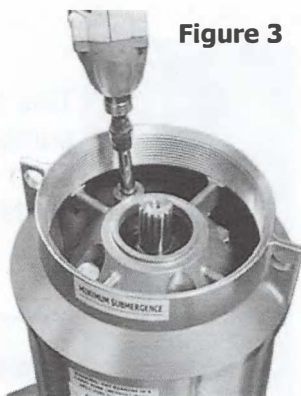
Figure 3

**3.** Remove the four bolts and lock washers holding the motor to the pump crown. (See Figure 3) These are 1/2" bolts. Please use caution and set the pump on a block to prevent the motor from "dropping" out of the casing. Cut the cable tie holding the motor lead to the pump foot.

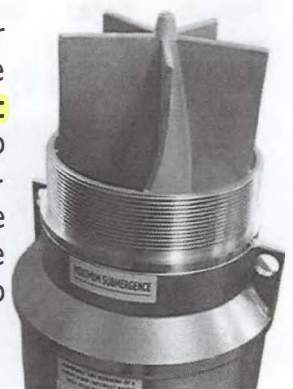
Figure 6

**8.** Replace the recuperator on the pump crown. (See Figure 6) **This has left handed threads.** To tighten turn counter-clockwise. This must be tight. Use wrenches on the recuperator and the crown to assist you.
